Multi-scale analysis of water alteration on the rockslope stability framework

MULTI-SCALE ANALYSIS OF WATER ALTERATION ON THE ROCKSLOPE STABILITY FRAMEWORK

KEY WORDS: Water, chemical degradation, rock discontinuity, stability.

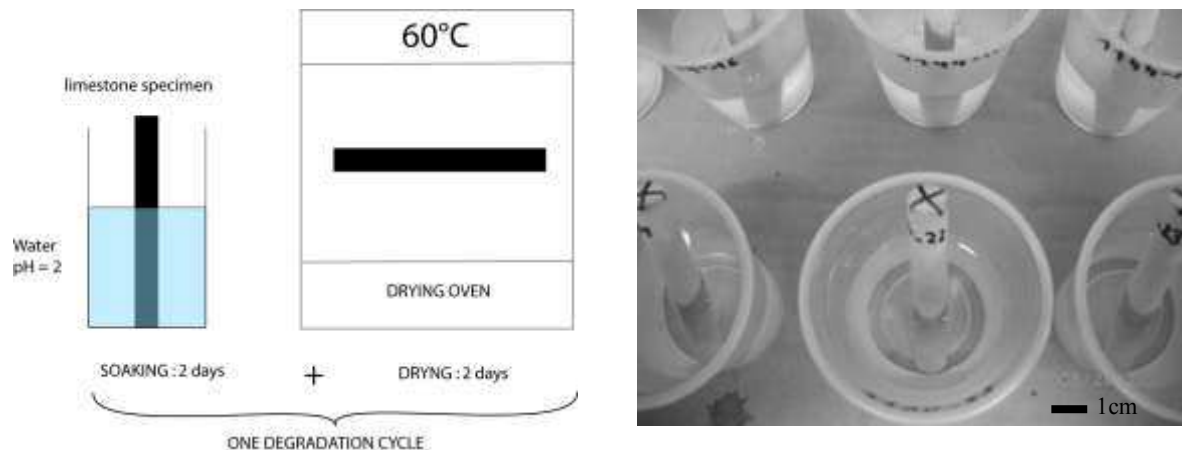
Figure 1: Schematic representation of the two steps of the experiment “alteration in quasi- static regime” which is composed of one cycle of weathering (left). Picture of the first phase of the experiment quasi-static regime limestone samples sticks are soaking in the acidic water (right).

This first experiment consists in leaving limestone's samples at rest in a fixed volume of acidic water (Figure 1). The evolution of weight of each samples during cycles of alteration are measured at different times. A cycle is composed of two steps. During the first step all samples are soaked 2 days in a sulfuric acid solution

at pH 2 then during the second step samples are dried at 60°C for 2 days (Figure 1). The acidic solution is renewed. Thanks to that change, the alteration is more effective by repetitions of these cycles, *in fine*, the samples degradation is increased.

The rock samples are cylindrical (diameter: 12 mm, high 100 mm) (Figure 1). A number of 24 sticks samples are used for each type of limestone. We used four types of limestone: Pierre de Caen (Caen Stone), Pierre de Lens (Lens Stone), Larrys and Comblanchien whose differ by their porosity. Limestones' porosity extend to a range from one to several tens percent. Caen Stone and Lens Stone have a high porosity respectively 20% and 17%, whereas the two others have a low one respectively 7% and 1%.

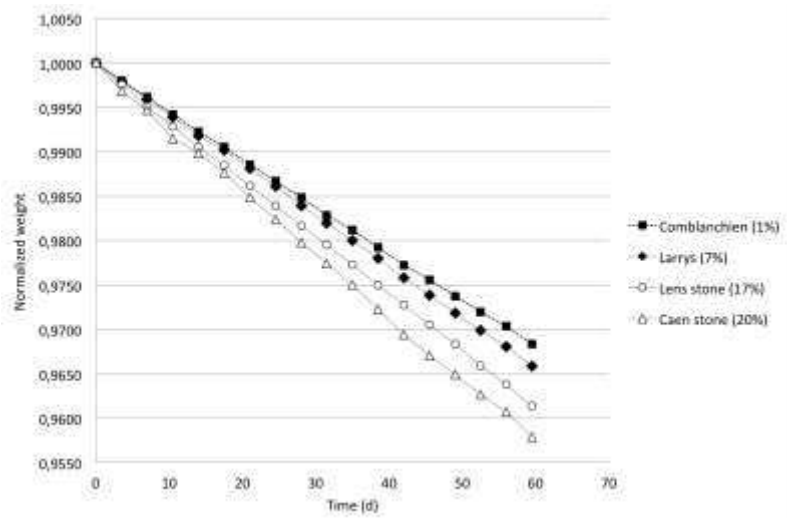
Figure 2: Evolution of sample weight during the experiment Alteration in static regime.

The evolution of each sample weight is measured during the dissolution process. A decrease of weight is measured for each type of limestone. Figure 2 represents normalized weight (weight (t)/weight (0)) versus time of degradation. We noticed linearity with time of the loss of weight for all the type of limestone (Figure 2). This indicates there is a constant rate of dissolution for limestone. In this figure below, we can observe that whatever the giving porosity the rate of decreasing weight is quite constant. However we can observe the higher the porosity, the higher the rate. This difference of rate means that the dissolution process also affects the pores of the matrix although the pore pressure is very small. Moreover the dissolution process has a higher influence on the more porous sample (Caen stone).

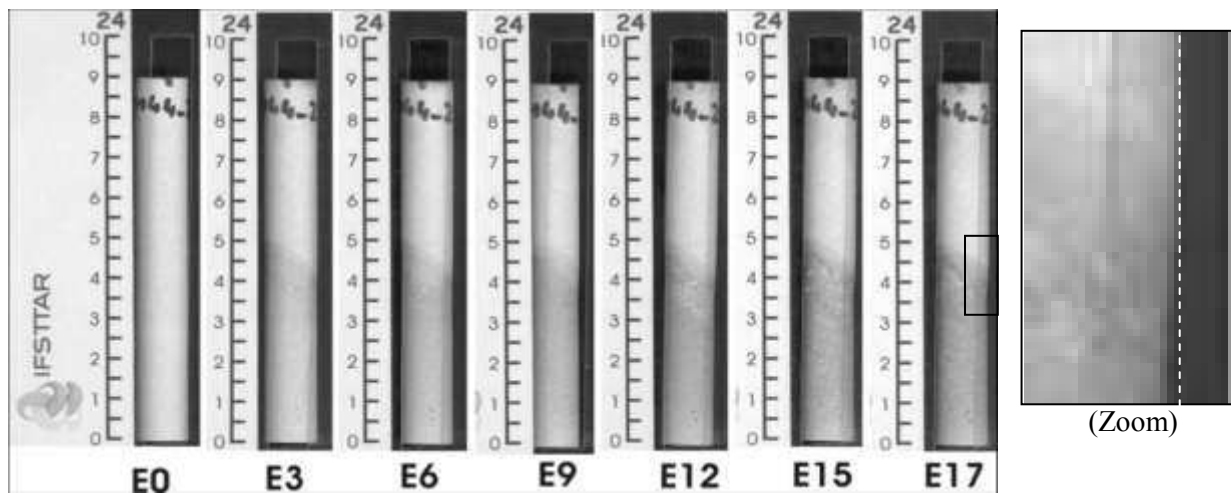
Figure 3: Pictures of Caen Stone samples: Initial state (E0), after 10 days (E3), 20 days (E6), 30 days (E9), 40 days (E12), 50 days (E15) and 60 days (E17).

At the fluid-air interface recognized by the different of coloring, a recession of the surface is observed for each sample of each limestone (Figure 3, Figure 4). This recession suggests a loss of material. The high degradation in this part of the sample is also attributed to the influence of the CO_2 in ambient air. Actually, CO_2 is considered as an important acidifying component of water. The interface is the place where the exchange between ambient air and the water near the surface is the most important, makes it a zone where degradation is improved.

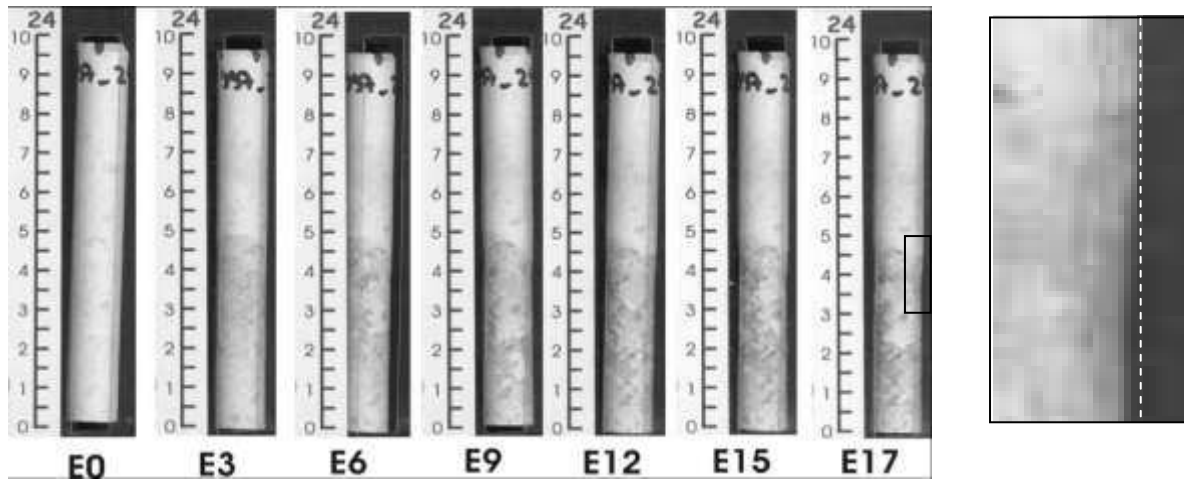
Figure 4: Pictures of Larrys samples during alteration: Initial state (E0), after 10 days (E3), 20 days (E6), 30 days (E9), 40 days (E12), 50 days (E15) and 60 days (E17).

We observe the same high degradation near the interface, for all types of limestone. This information suggests an influence of CO_2 whatever the porosity.

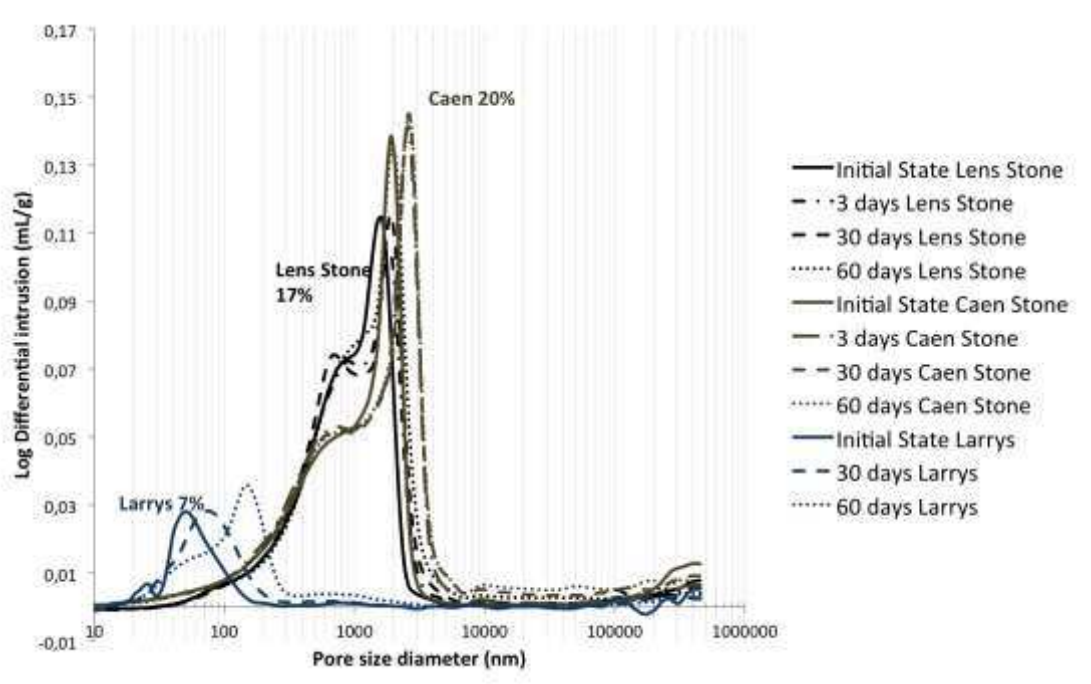
Figure 5: Volume of mercury intrusion versus pore size diameter for samples of Lens Stone, Caen Stone and Larrys and for several state of weathering

In order to evaluate the different states of alteration of the porous matrix evolution inside the sample, mercury intrusion porosimetry (MIP) measures have been done. This method is commonly used to evaluate the total porosity and the pore size distribution of different materials. MIP results are expressed as the total mercury volume intruded (log differential intrusion) in a sample versus pore size (mean diameter pore). Measures were carried out after several cycles of degradation. The Figure 5 shows the volume of mercury intrusion versus the pore diameter. We represent on the graph three of the four limestone used for the study (Larrys (7%) Lens Stone (17%) and Caen Stone (20%)). First of all we can observe the mean pore diameter increases with the limestone's porosity. Then for each type of limestone there is an increase of the mean pore diameter between the initial state and 3 days of alteration. The alteration increase pore volume. Low porosity sample have little mean pore diameter whereas high porosity have their mean diameter higher. Matrix of Lens Stone and Caen Stone samples are modified after the first cycle. Indeed an aperture of the mean diameter pore is measured after the first cycle but the mean diameter doesn't increase for the other cycles. Nevertheless on Lens Stone, the volume of mercury increases between 30 days and 60 days of alteration. This reveals an increase of pores with same size. Larrys' samples show an increase of the mean diameter pore all along the state of degradation (Figure 5).

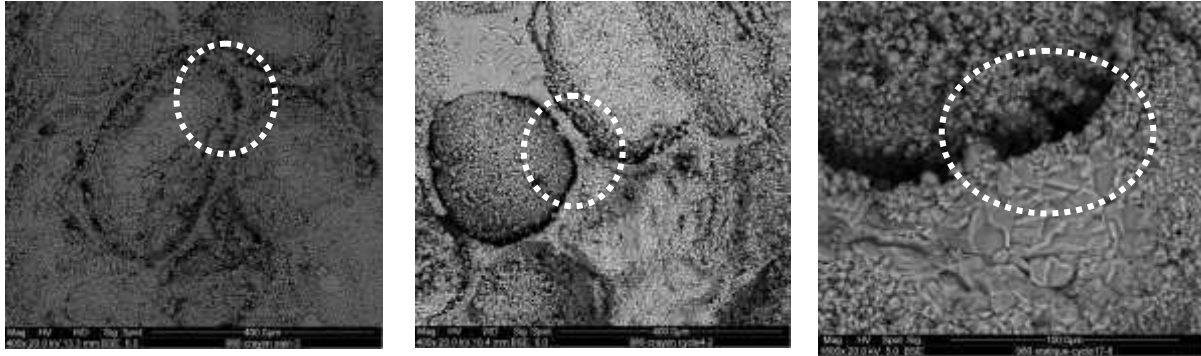
Figure 6: ESEM pictures from sample of Lens Stone at initial state (left) after 10 days (middle) and after 60 days (right). The dash line circles emphasize the gap between oolites; this gap was created during the alteration.

We observe sample of limestone named Lens Stone at micro-scale with an environmental scanning electron microscope (ESEM) (Figure 6). These three pictures show three states of limestone degradation's at different time, the first represents non-altered sample, the second at 10 days of alteration and the last one after 60 days of alteration. The limestone observed is Lens Stone, it is composed of ooids which are spherical grains composed of concentric layers. We observe along the period of alteration a digging around the ooids, which indicates dissolution of calcite. This kind of feature shows the non-homogeneous fact of dissolution either at space scale.

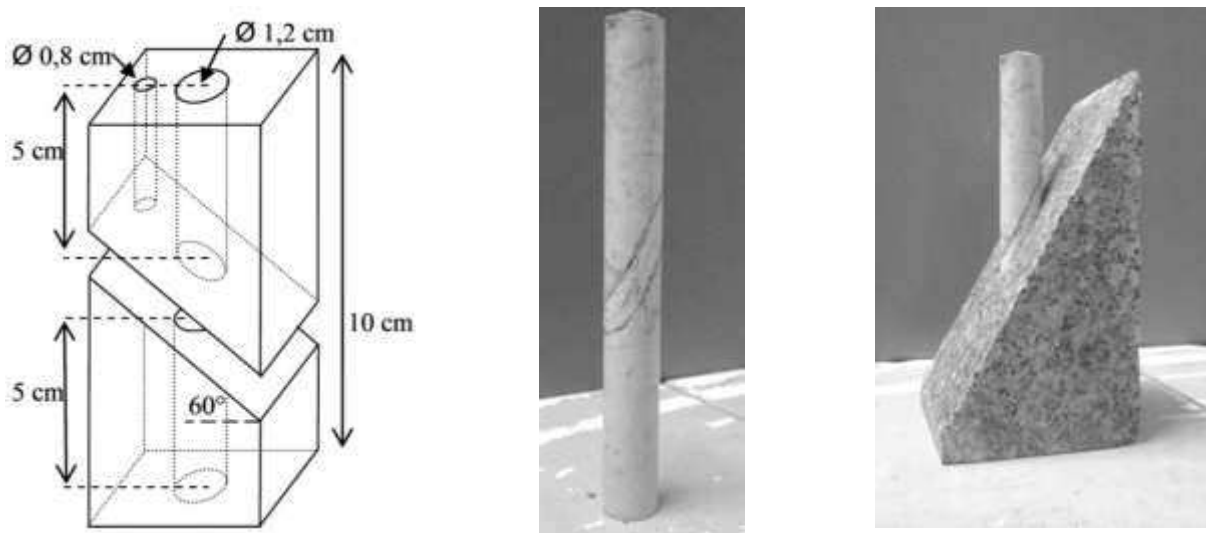
Figure 7: Shape of the granite base with dimension (left) the sample of limestone (middle) are inserted into the granite for the test (right) (after Druon)

In order to the observation and measurement of chemical degradation an evaluation of the mechanical response of the sample submitted to a shear loading is performed. The measurements are made with a uniaxial cell in order to evaluate the influence of alteration on the mechanical properties of limestone samples. We used cylindrical samples (Figure 7) as samples in the alteration in quasi-static experiment. Each sample is positioned in a shaped granite base (Figure 7) and put in the uniaxial cell (Figure 8).

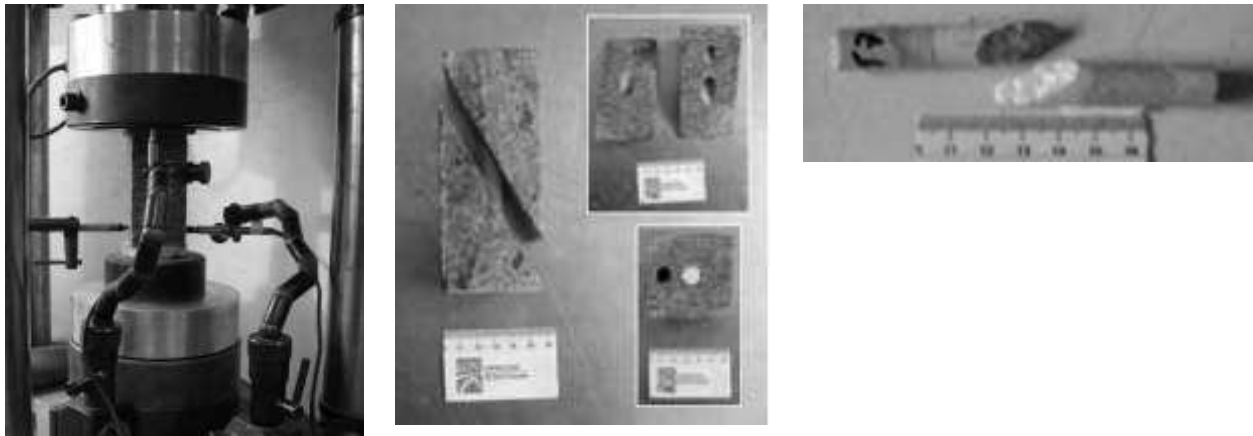
Figure 8: Picture of the uniaxial cell used for the experiment “alteration quasi-static” (left). Sample in the granite base (middle) and the broken sample after the test (right) (after Druon).

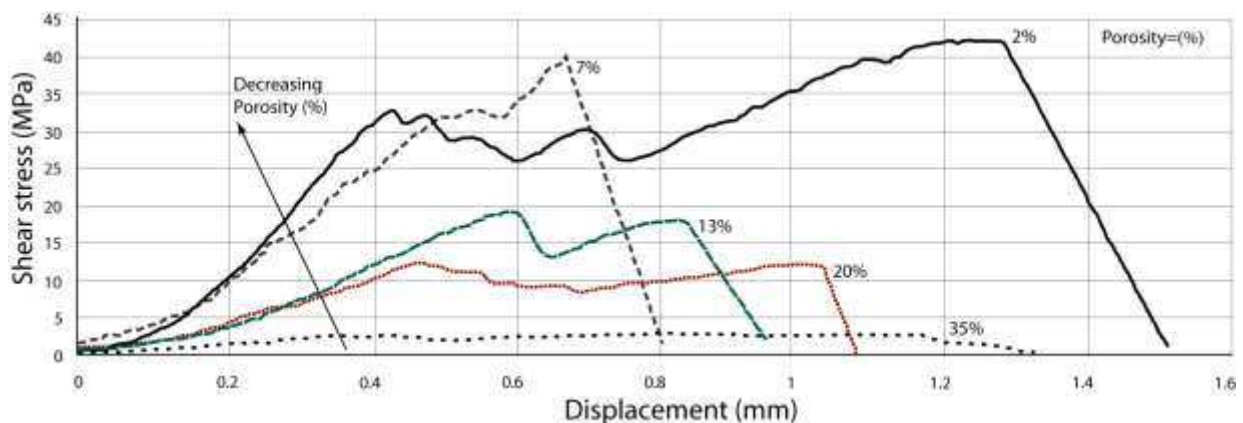
Figure 9: Shear stress versus tangential displacement for different limestone’s porosity (modified from Druon, 2011 [10]).

Shear strength measurements are performed on different non-altered limestone samples on a range of porosity 2% from 35 % (Figure 9). The different curves show an increase in the shear stress versus tangential displacement until a peak is reached and then a decrease followed by an increase to a maximum and then failed. The first stress drop is associated to micro-cracks of the sample and the final stress drop is related to the failure of the sample. All limestone samples seem to have the same behavior.

We noticed the smaller the porosity the stronger slope, this implies that the slope of curves is hardening with the decreasing porosity. It suggests porosity affects the mechanical response of samples.

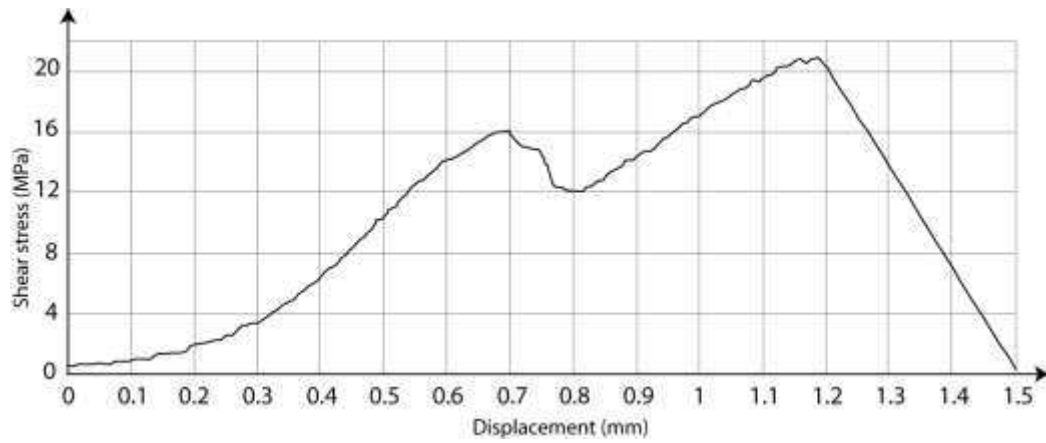
Figure 10: Evolution of shear stress versus tangential displacement for the limestone Larrys (modified from Druon, 2011).

The following experiment focused on non-altered Larrys (7%) sample. The Figure 10 shows the evolution of shear stress versus tangential displacement. The curve shows an increase to a peak at 16 MPa and a decrease to 12 MPa. This first part of the curve with the little peak, indicate a first micro-crack in the limestone sample. After that the shear stress rises to a maximum at 21 MPa and after the shear stress collapse. This part of the curve represents the rupture of the sample.

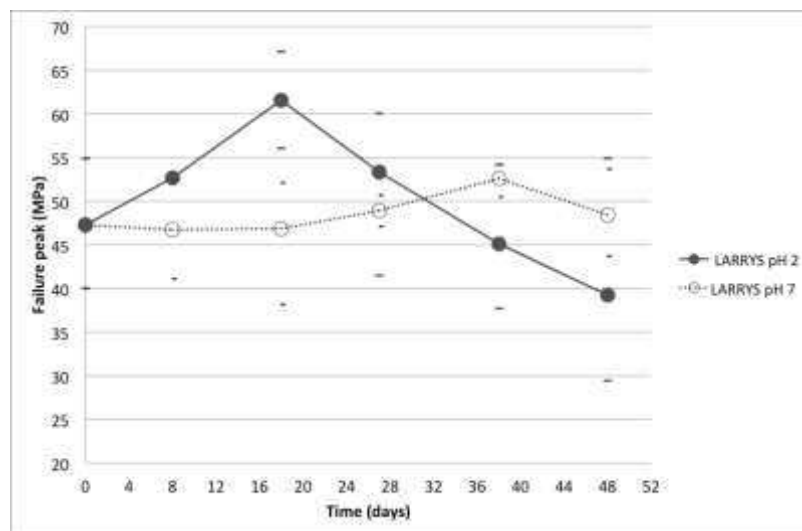
Figure 11: Evolution of the mean failure peak after period of alteration for Larrys limestones. A comparison between different water, acid (pH 2) and neutral (pH7). Dashes (above and below) represent respectively the standard deviations max and min. The small dashes for pH2, and the large dashes for pH 7(modified from Druon, 2011).

The Figure 11 shows the evolution of Larrys' samples mean failure peak during alteration period for two different pH degree of water (pH 2 and neutral water pH (7)). Which is surprising in that two curves show an increase of mean peak rupture to a maximum and a decrease. They have the same shape except the maximum for the acid water (pH 2) appears before that for rain water (pH 7). The difference between the curves points out the acceleration process of dissolution. The comparison between two different pH degrees of water shows how much the influence of pH water is relevant during the alteration process. Furthermore the slope before the peak for the pH 2 curve is stronger than the slope for pH 7.

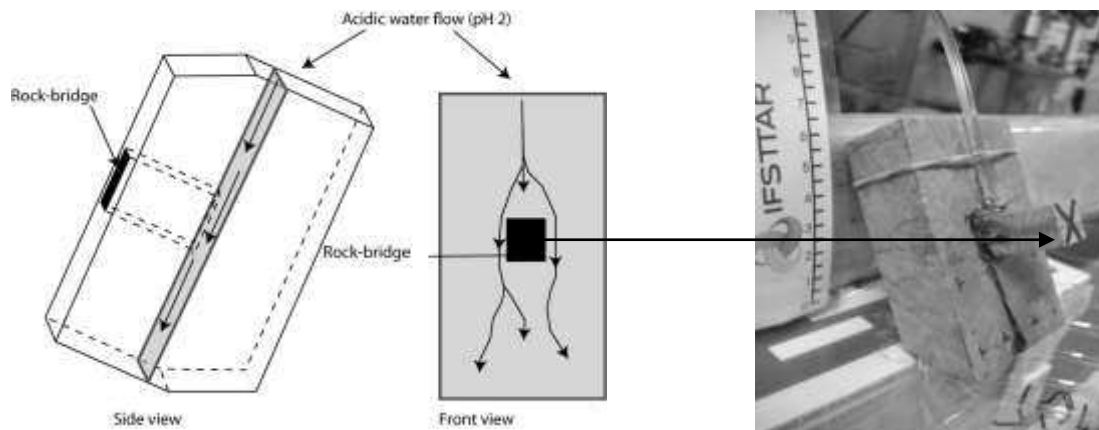
Figure 12: Schemes of the shape limestone samples for the experiment Alteration in the case of “flowing water”, the acid solution is in drip system, the flow is one liter of solution per day, and run along the discontinuity and around the rock bridge (left). Picture of the runoff along the discontinuity and around the rock-bridge (right).

It exists [11] [12], part in the rock mass which is connected to the block ready to fall. These parts are called *rock-bridge* and they constitute the block stability. In this experiment, the shape of the sample and the water flow are different from the first one. Limestone's blocks are sawn so as to leave a continuous part, called rock bridge. The rectangular geometry of the bridge is connected to the surface of the block. The above part is taken off. The experiment is realized in open system where CO_2 of the atmosphere can influence the interaction between the acidic solution and the surface of the block because CO_2 is known to acidify water. The acidic solution is stored in tins and the solution flows via a drip system. The water flow is about one liter per day (Figure 12).

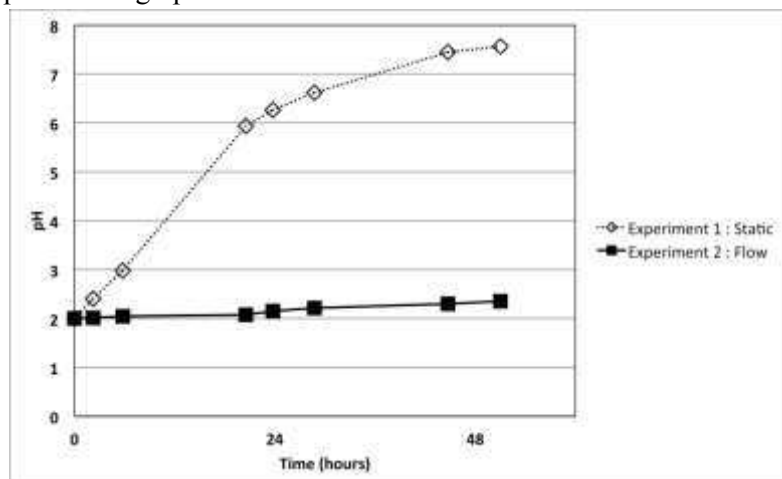
Figure 13: Representation of the evolution of pH as a function of time, the dotted curve with open symbols shows the evolution in the case of an alteration in static water regime: limestones (CaCO_3) are soaking in an acidic solution (H_2O ; H_2SO_4). The solid curve and filled symbols shows the evolution in the case of an acidic solution flows along the limestone.

Figure 13 depicts the time evolution of water pH during two different experiments. A continuous flow on the limestone surface; maintains pH stability around 2 whereas limestone's sample immersion in an acidic solution buffers it at pH 7. This graph shows how time-contact between rock and solution is relevant.

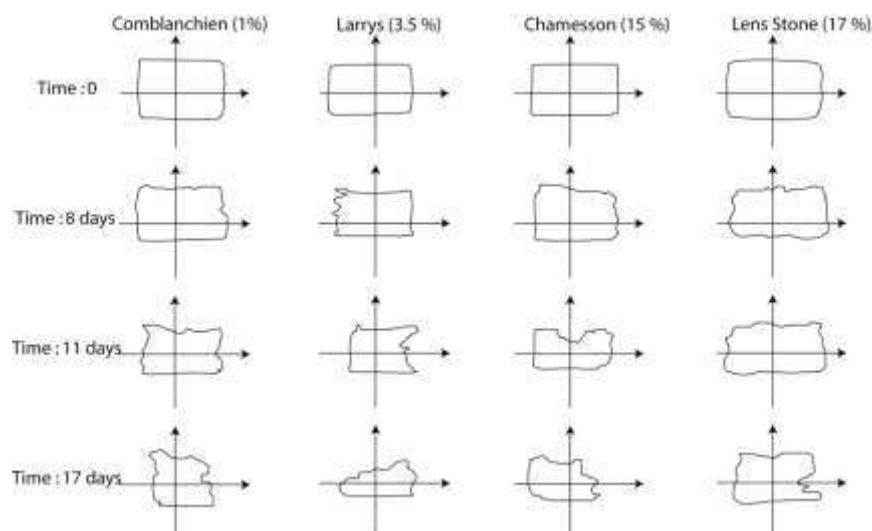
Figure 15: Comparison between the different states of alteration for each limestone of their rock bridges' perimeter measured with laser.

Each type of limestone received 12 liters of acid solution flowed for a period of 17 days. After 8, 11 and 17 days, a geometric analysis by laser is performed. Many profiles were done in order to show the influence of the alteration surface and to establish the decreasing of the rock bridge perimeter. This decreasing of the perimeter is observed during the water flowing for all samples (Figure 15). In addition we noticed an intact part of the rock bridge below. The recession of the rock-bridge perimeter may imply a decrease of the mechanical resistance of the rock bridge.

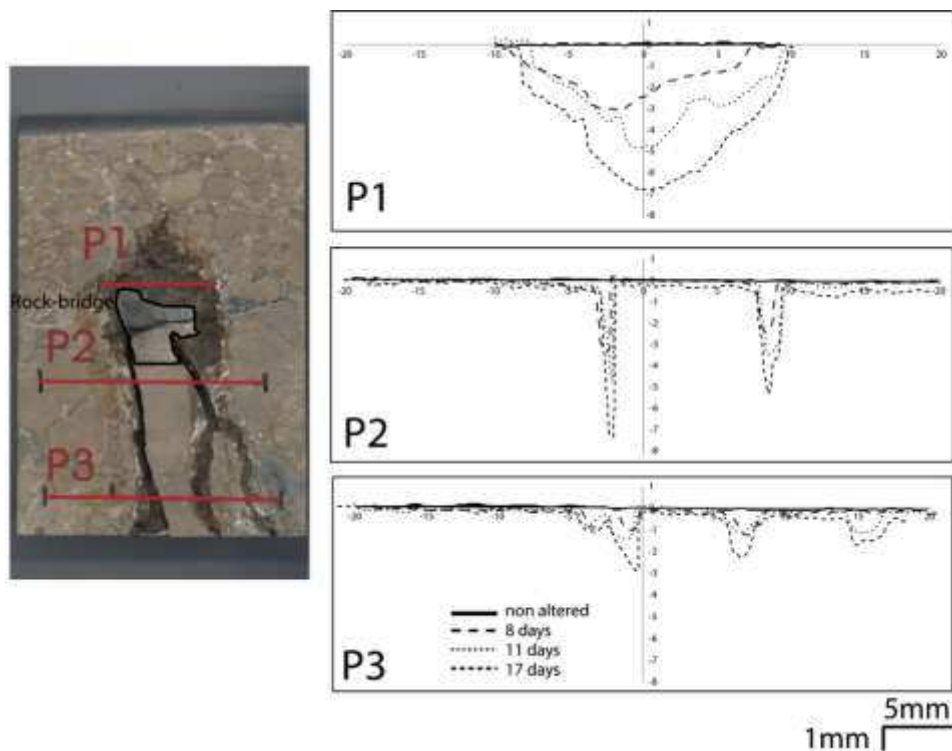
Figure 16: Montagnole sample after acidic water runoff, line P1, P2, P3 represent the place we take the profile by laser (left). These graphs represent the 3 profiles done by laser, the different curves show the evolution of the “topography” of the sample surface during alteration period (right)

We performed other laser profiles (Figure 16). Profile P1 was taken above the bridge then profile P2 just under the bridge, and the third P3 was measured on the below far from the bridge (Figure 16). These profiles were made at initial state, after 8 days of runoff, 11 days and at final state (17 days). Profile P1 is made near the place where the drop fell. It shows a digging which increases significantly over time. Profiles under the

bridge show two diggings (P2) then three (P3). These paths followed small fractures. These ones indicates preferential path of water circulation (P2 and P3).

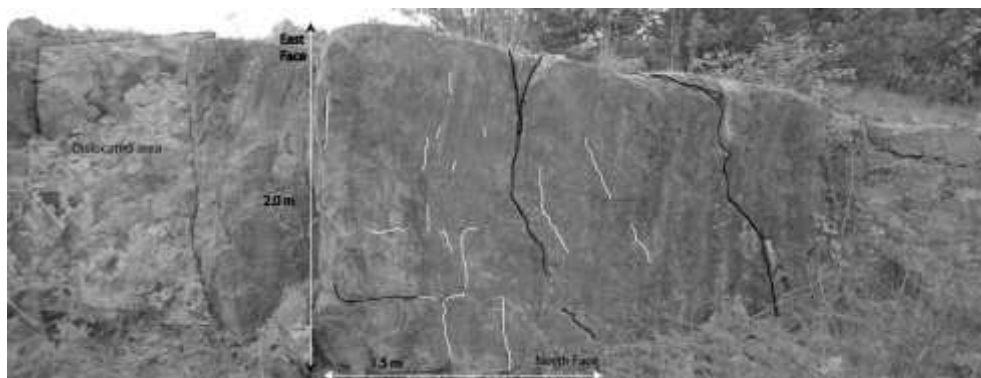
Figure 17: View of the rock mass, it presents a dislocated area on the left, and major discontinuities are in black and superficial are in white.

The site is located in Montagnole near Chambéry (73) in France. The block is a triangle shaped dihedral with fractures and it is apparently ready to fall (Figure 17). This work aims to evaluate the potential of Ground Penetrating Radar (GPR) measurements to find and estimate the quantity of rock bridges into a block with a discontinuity.

The first observation in situ reveals many discontinuities; the major ones represented in black on Figure 17 are those where we suppose there are rock bridges to maintain the stability of the rock mass. The white ones appear to be just on the surface but they are important for the surface degradation. The GPR reveals the possibility to identify the surface discontinuity (Figure 19). As a matter of fact radar-gram present some weirdness, these ones are the proofs of different environment as air or rock mass. These are analyzed and after a treatment, a 3D view of the discontinuity surface could be made as Figure 20 shows.

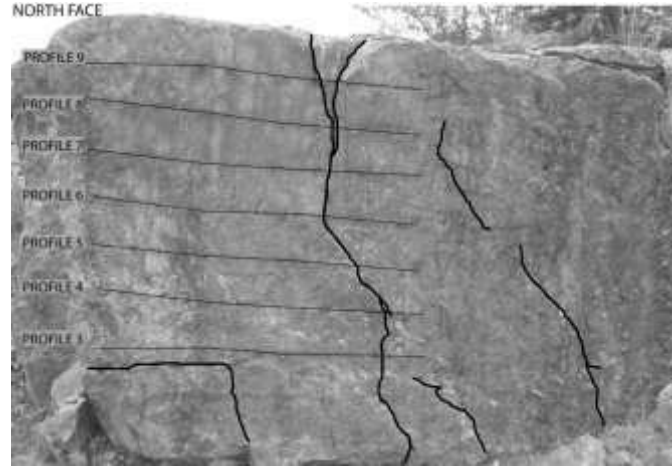
Figure 18: Depict of the North Face of the block in Chambéry (73). The black lines reveal the different discontinuities observed. The black horizontal lines identified each radar profile, profile 3 to 9 from the bottom to the top.

GPR data were acquired using high frequency (1600 MHz) to estimate the presence of rock bridges (continuity in the rock mass). This high frequency is adapted to detect interfaces such as rock-air-rock in two meters thick. The air tends to disperse the signal, so we can deduce the rock bridge's presence or not. In this paper, GPR measurements consisted in profiles acquired from the block (Figure 18), in order to make a grid of the block and identify the presence of rock bridges.

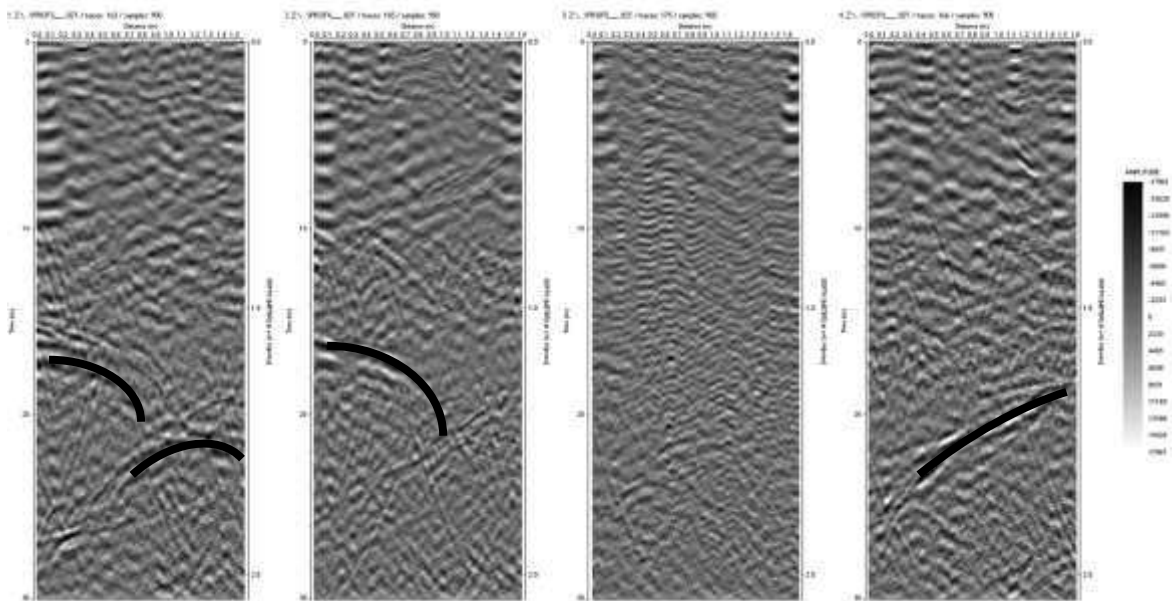
Figure 19: Radar gram acquired after profiles from the block, profile 3 to 6, the black lines represented the weirdness observed and used for the 3D representation.

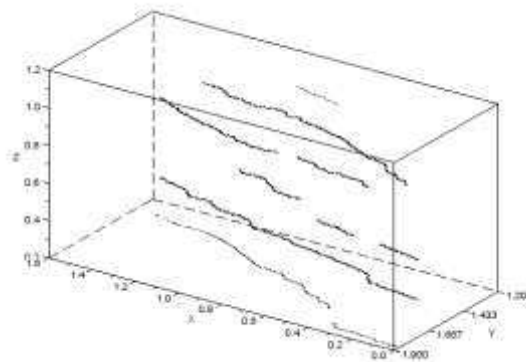
Figure 20: 3D view of the surface discontinuity after analyze and treatment of the data.

Figure 20 show horizontal dots, which represented the separation between rocks and void i.e. the discontinuity inside the block.
